AERONAUTICAL MATERIALS LABORATORY

REPORT NO. NAEC-AML-2436

DATE 11 MAY 1966

DEVELOPMENT OF AN ENVIRONMENTAL WET TEST CHAMBER FOR
SIMULATING CARRIER DECK AND OTHER CORROSIVE ENVIRONMENTS

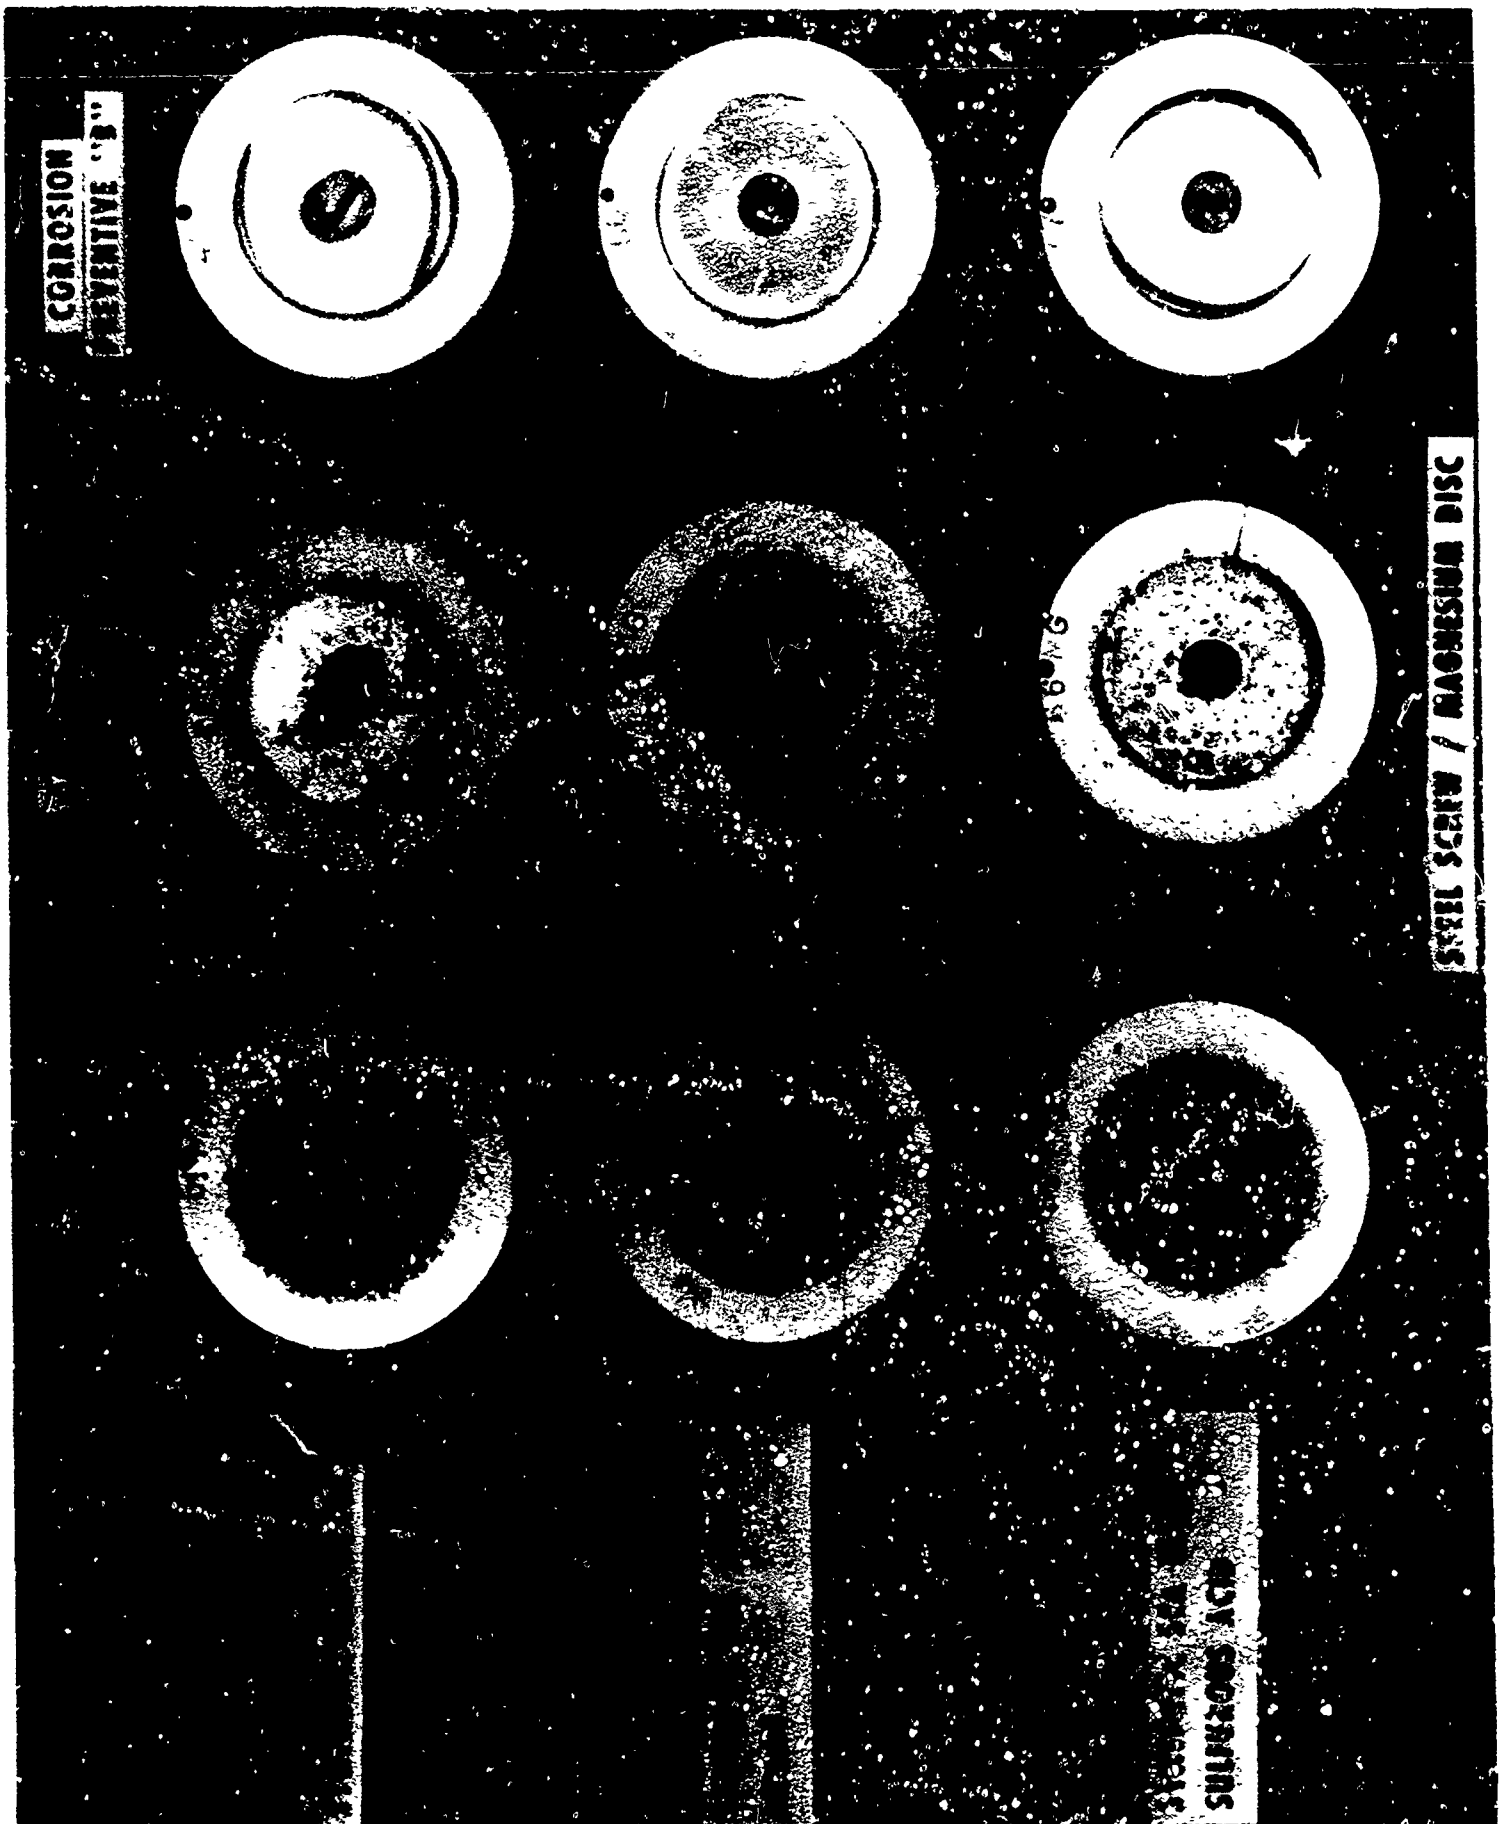
PLATE 11

RESULTS OF EXPOSURE OF DISSIMILAR METAL SPECIMENS TO SYNTHETIC SEA WATER, SYNTHETIC SEA WATER/SMOKE, AND SYNTHETIC SEA WATER/ACID ENVIRONMENTS

A critical comparison of the specimens exposed to the natural sea water environments with those exposed to the synthetic sea water environments showed that with the latter the corrosion appeared to be more severe but the difference was insignificant. This demonstrated the feasibility of using synthetic sea water in tests simulating coastal or shipboard atmospheres. The specimens referred to are shown in Plates 7, 8, 10 and 11.

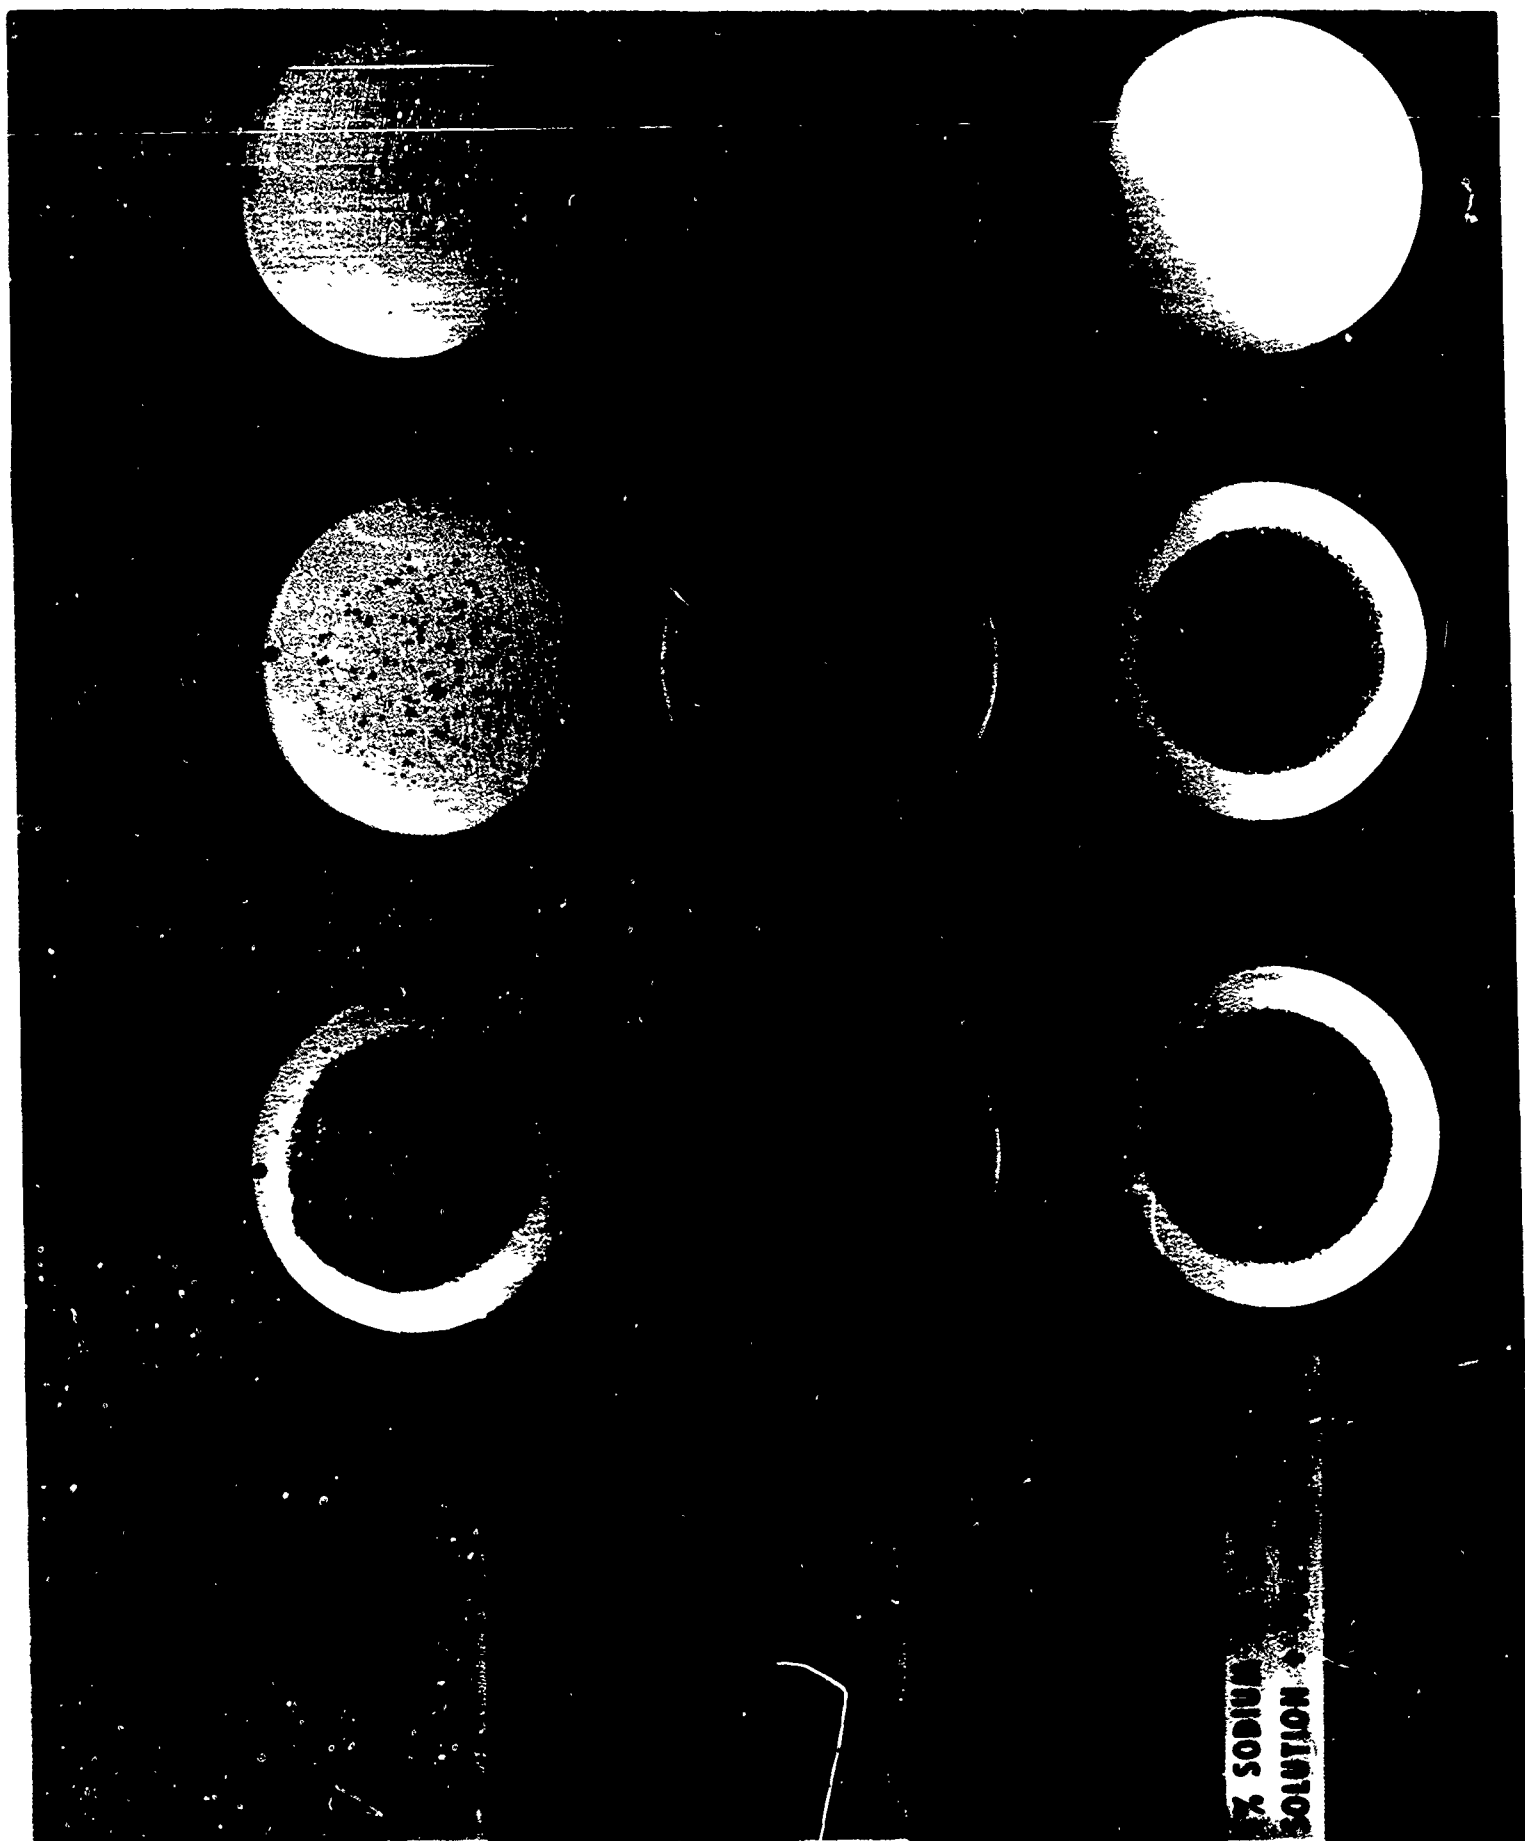
PLATE 13

RESULTS OF EXPOSURE OF STEEL SPECIMENS TO 5% NaCl SOLUTION, 5% NaCl SOLUTION/
SMOKE, AND 5% NaCl SOLUTION/ACID ENVIRONMENTS

To demonstrate the versatility of the unit and further determine its suitability, additional corrodents were included, viz. 5% and 20% NaCl solutions. These were selected because they are used in the standard salt spray units and variations were effected here too by adding the diesel fuel combustion products or sulfurous acid. Plates 13 to 16 inclusive show the results of these tests.

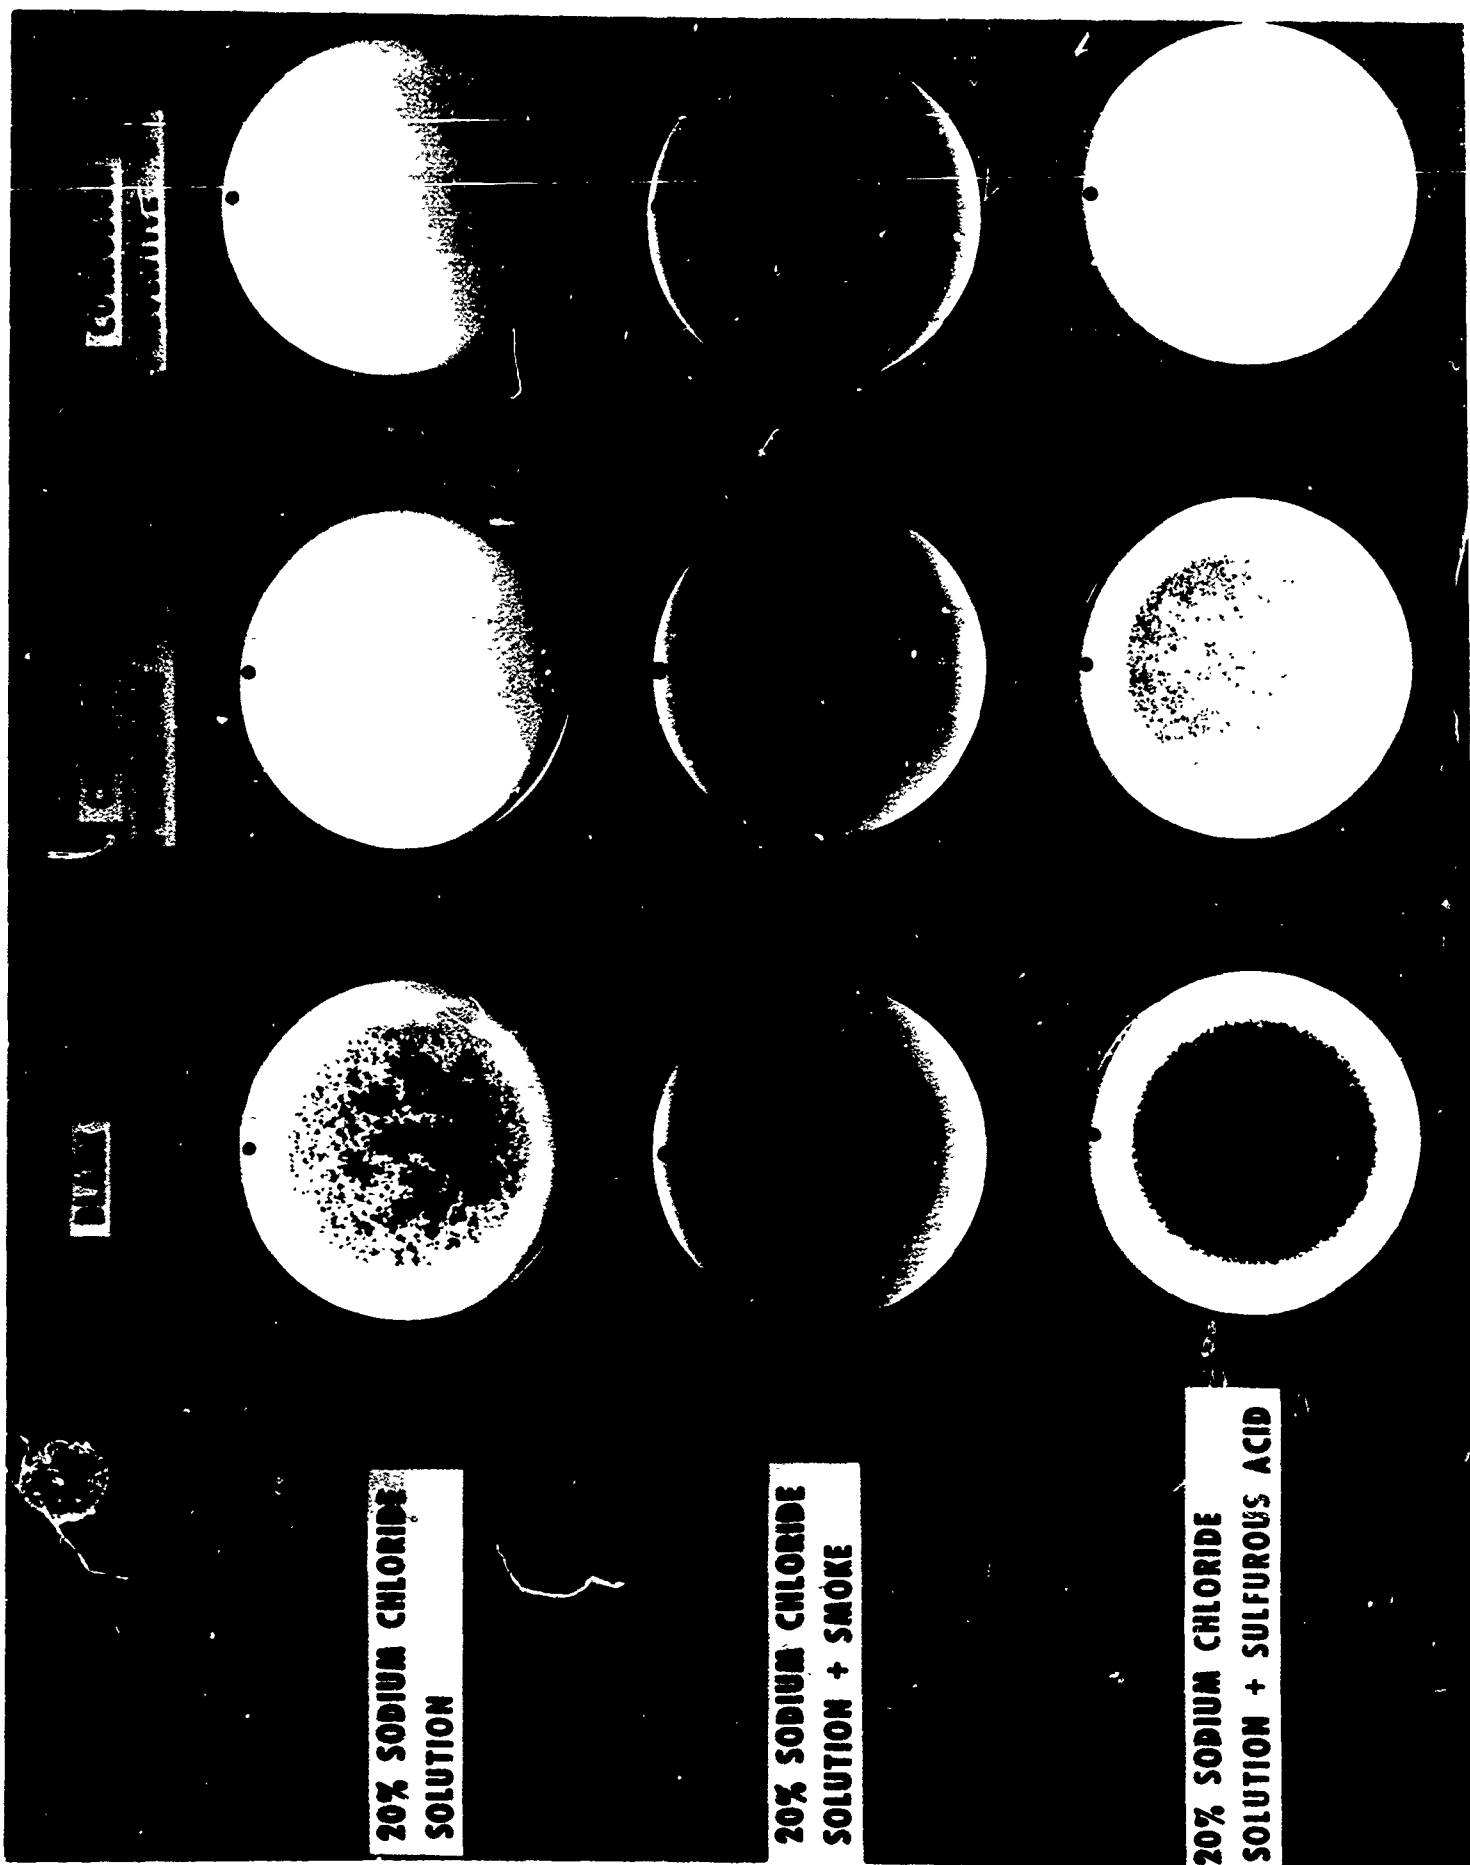
RESULTS OF EXPOSURE OF STEEL SPECIMENS TO 20% NaCl SOLUTION,
20% NaCl SOLUTION/SMOKE, AND 20% NaCl/ACID ENVIRONMENTS

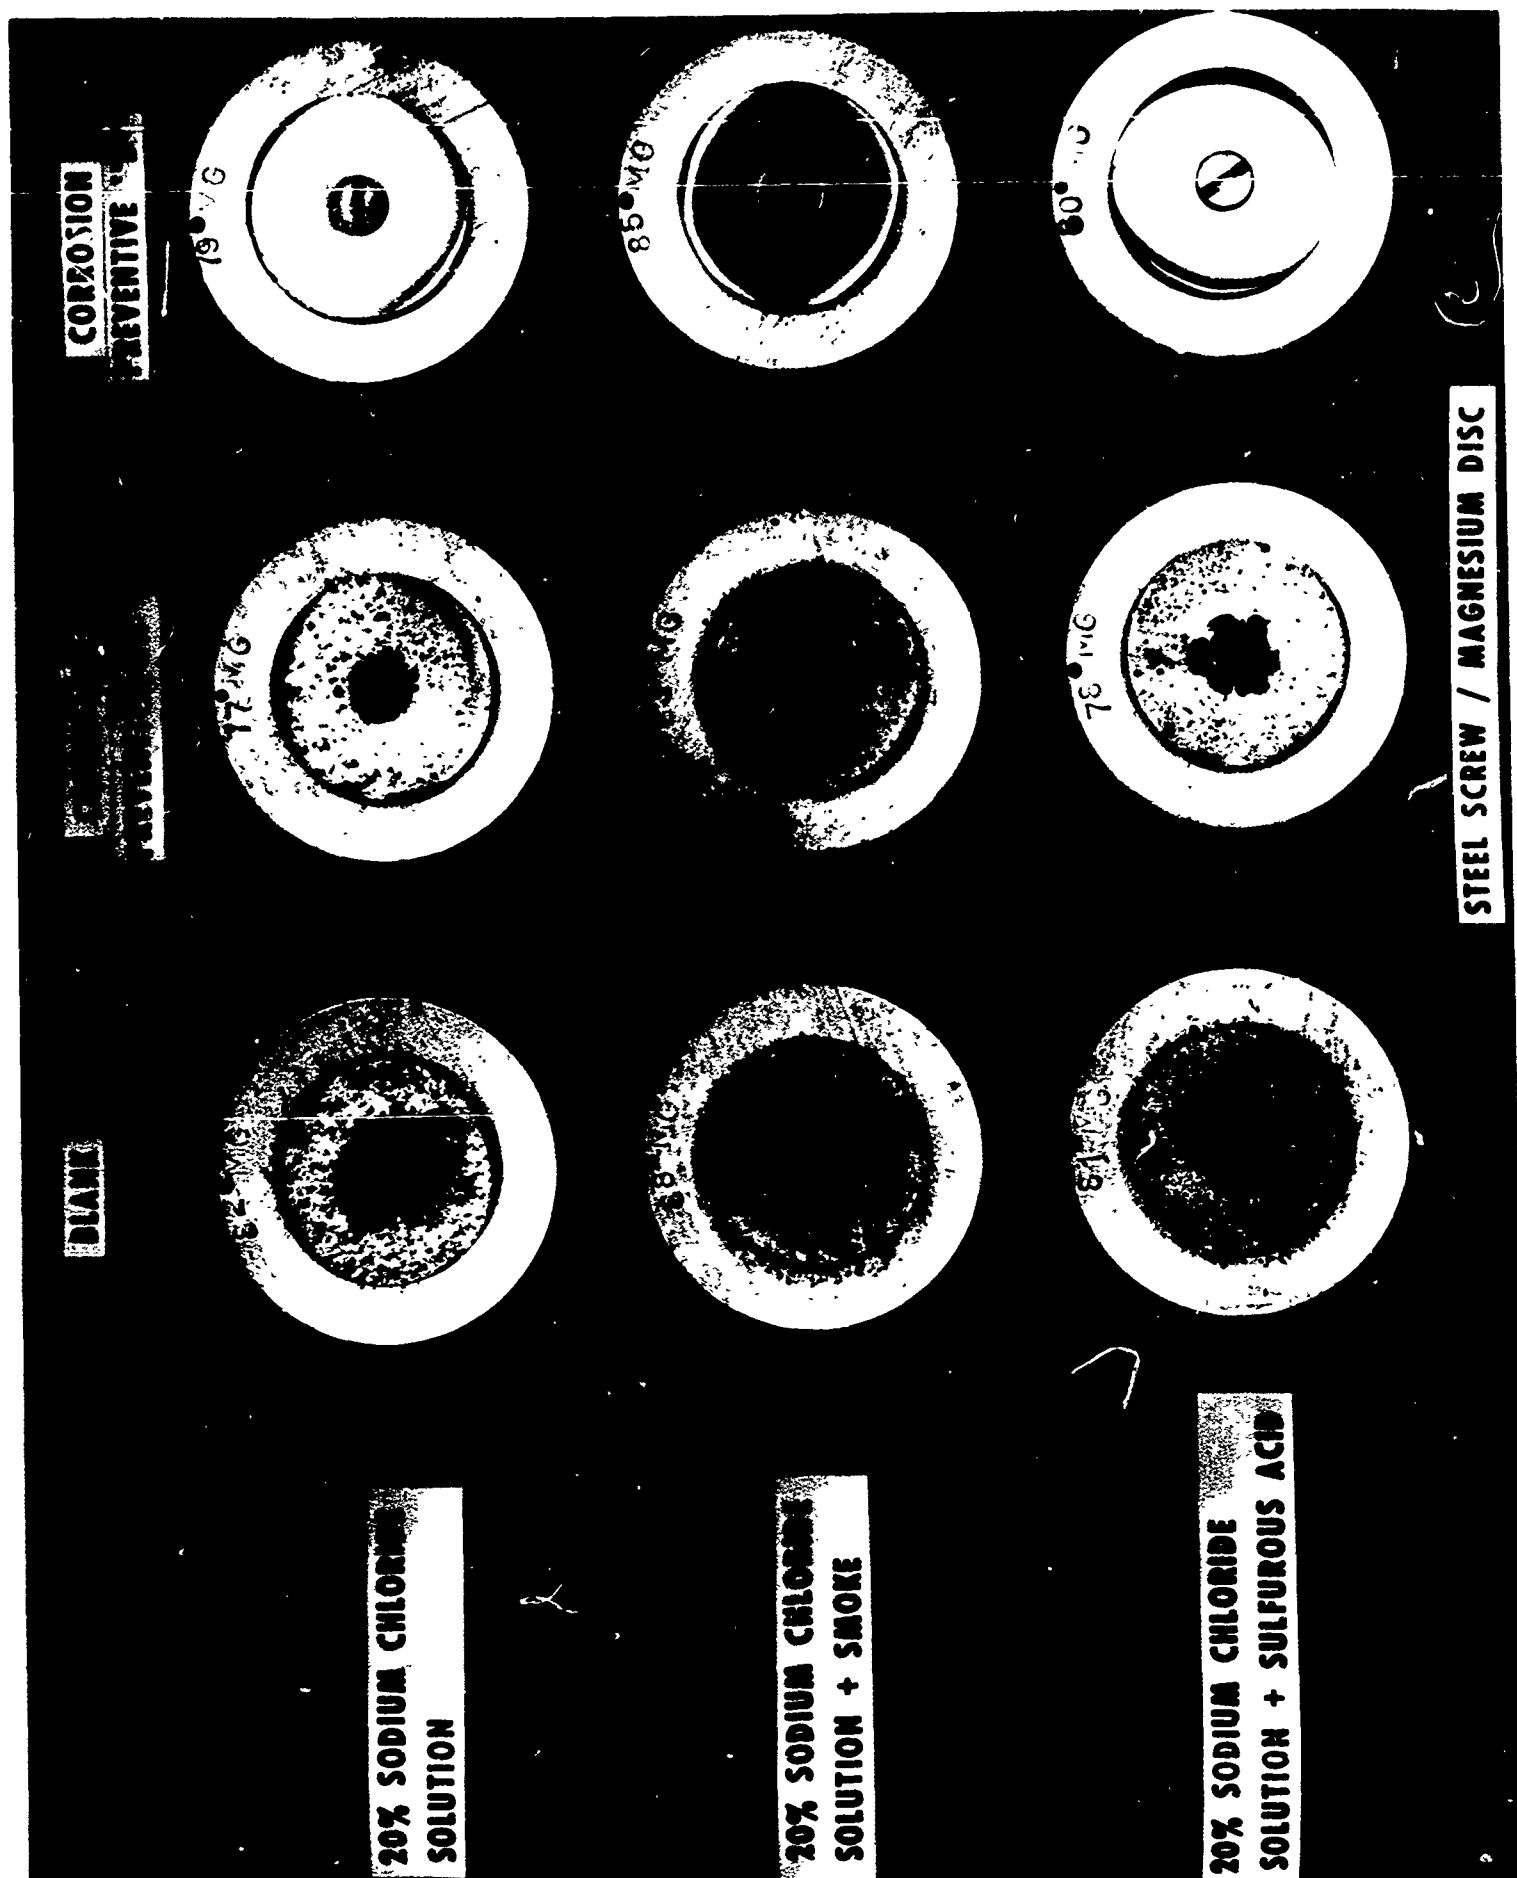
RESULTS OF EXPOSURE OF DISSIMILAR METAL SPECIMENS TO 20% NaCl SOLUTION, 20% NaCl SOLUTION/SMOKE, AND 20% NaCl/ACID ENVIRONMENTS

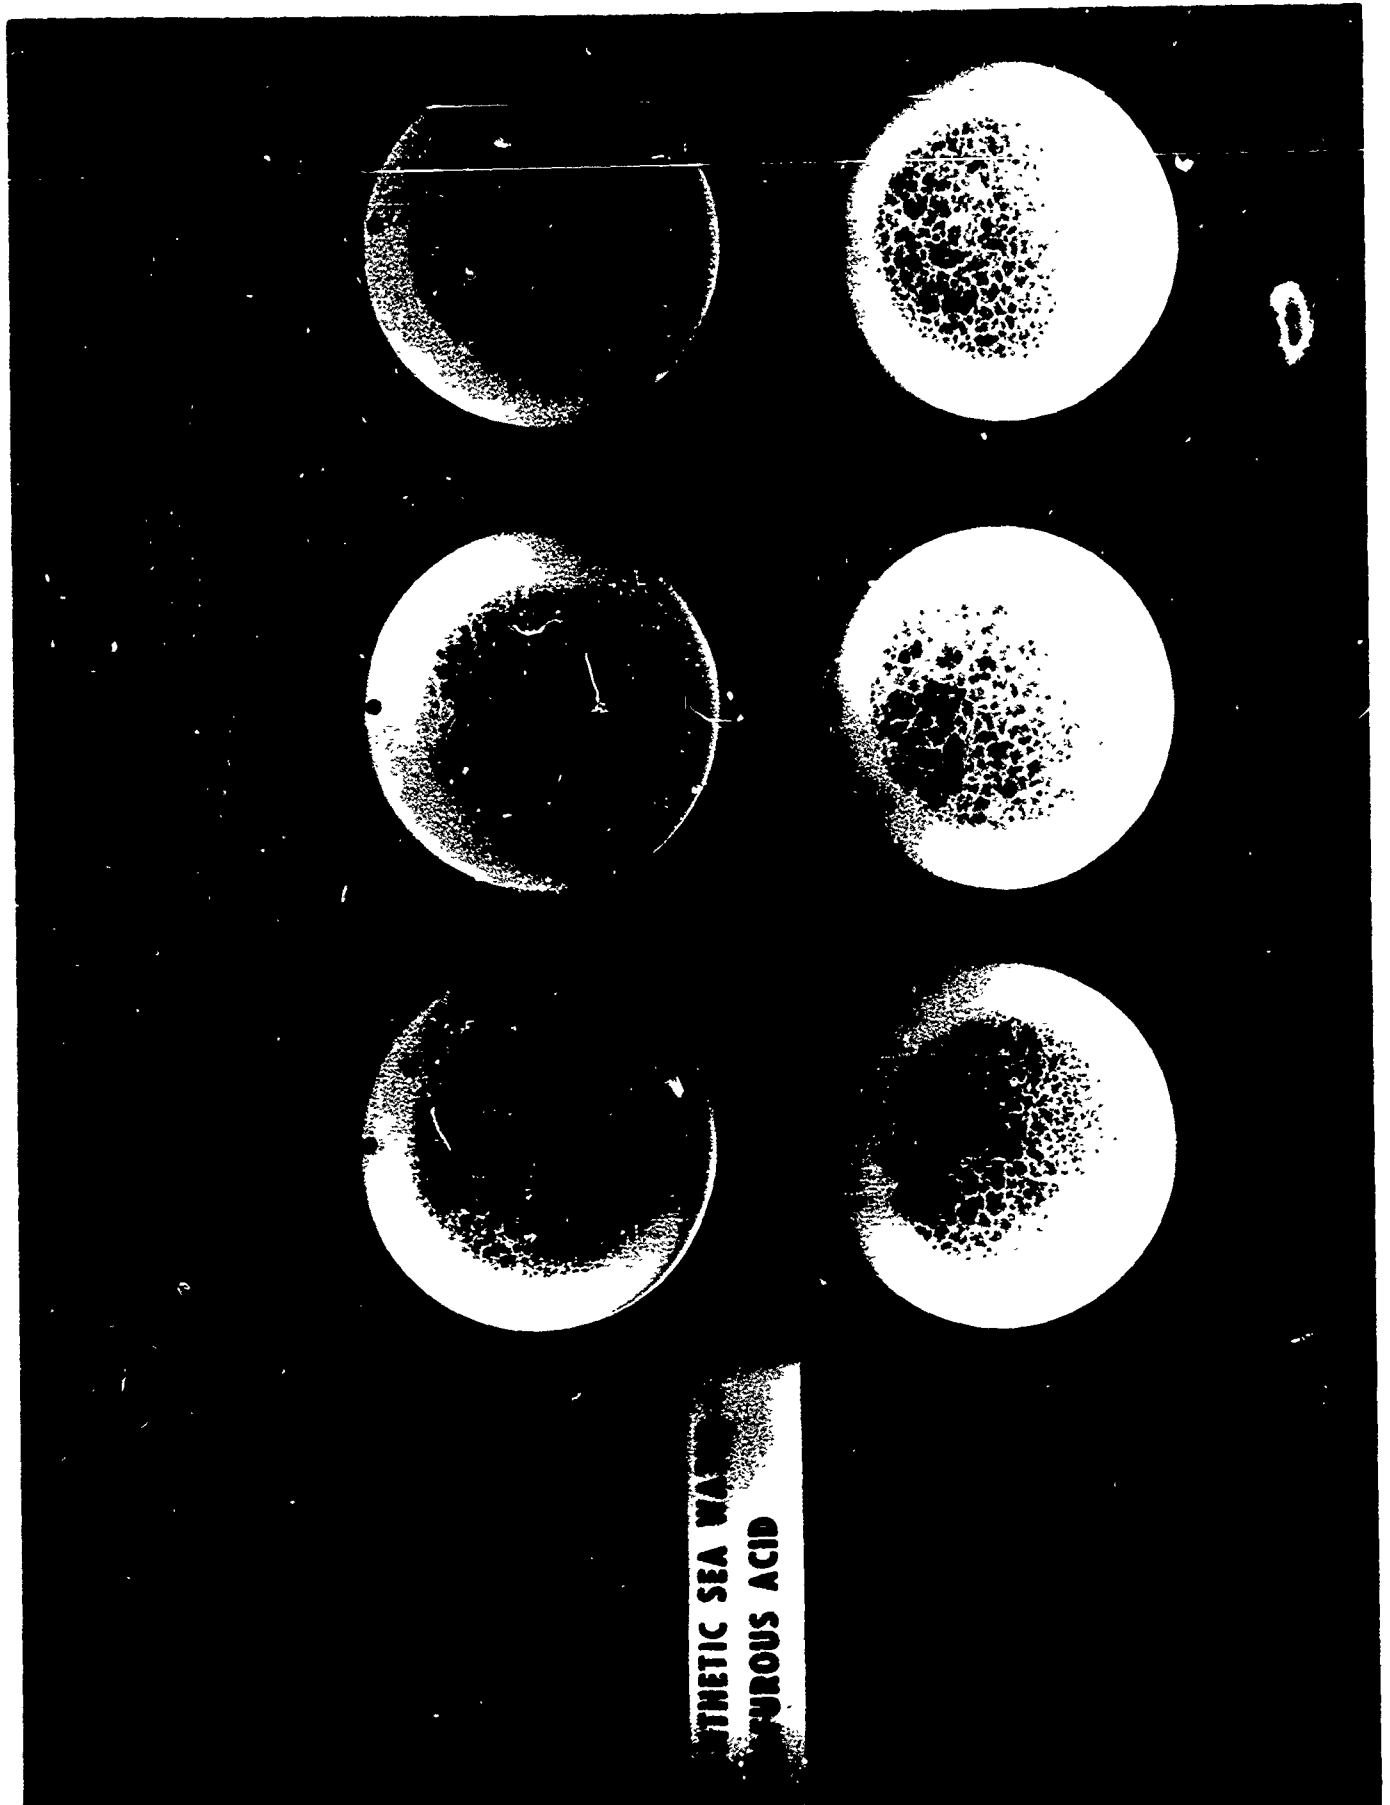
PLATE 17

RESULTS OF EXPOSURE OF STEEL SPECIMENS (COATED WITH A LIGHT OIL CONTAINING 35% INHIBITOR) TO A SYNTHETIC SEA WATER/ACID ENVIRONMENT

They were applied to 1020 steel discs and exposed in the wet test chamber to the synthetic sea water /SO₂ environment. The exposure cycle, identical to that used in all the previous tests, consisted of one hour exposure and a three hour drying period. The results of the tests, shown in Plates 17 to 19 inclusive, show a corresponding increase in protection with the increase of corrosion inhibitor. Specifically, sample C displays a moderately heavy corrosion pattern, sample D a somewhat similar pattern but corrosion not as intense, while E displays very light, scattered rust spotting on each of the six discs.

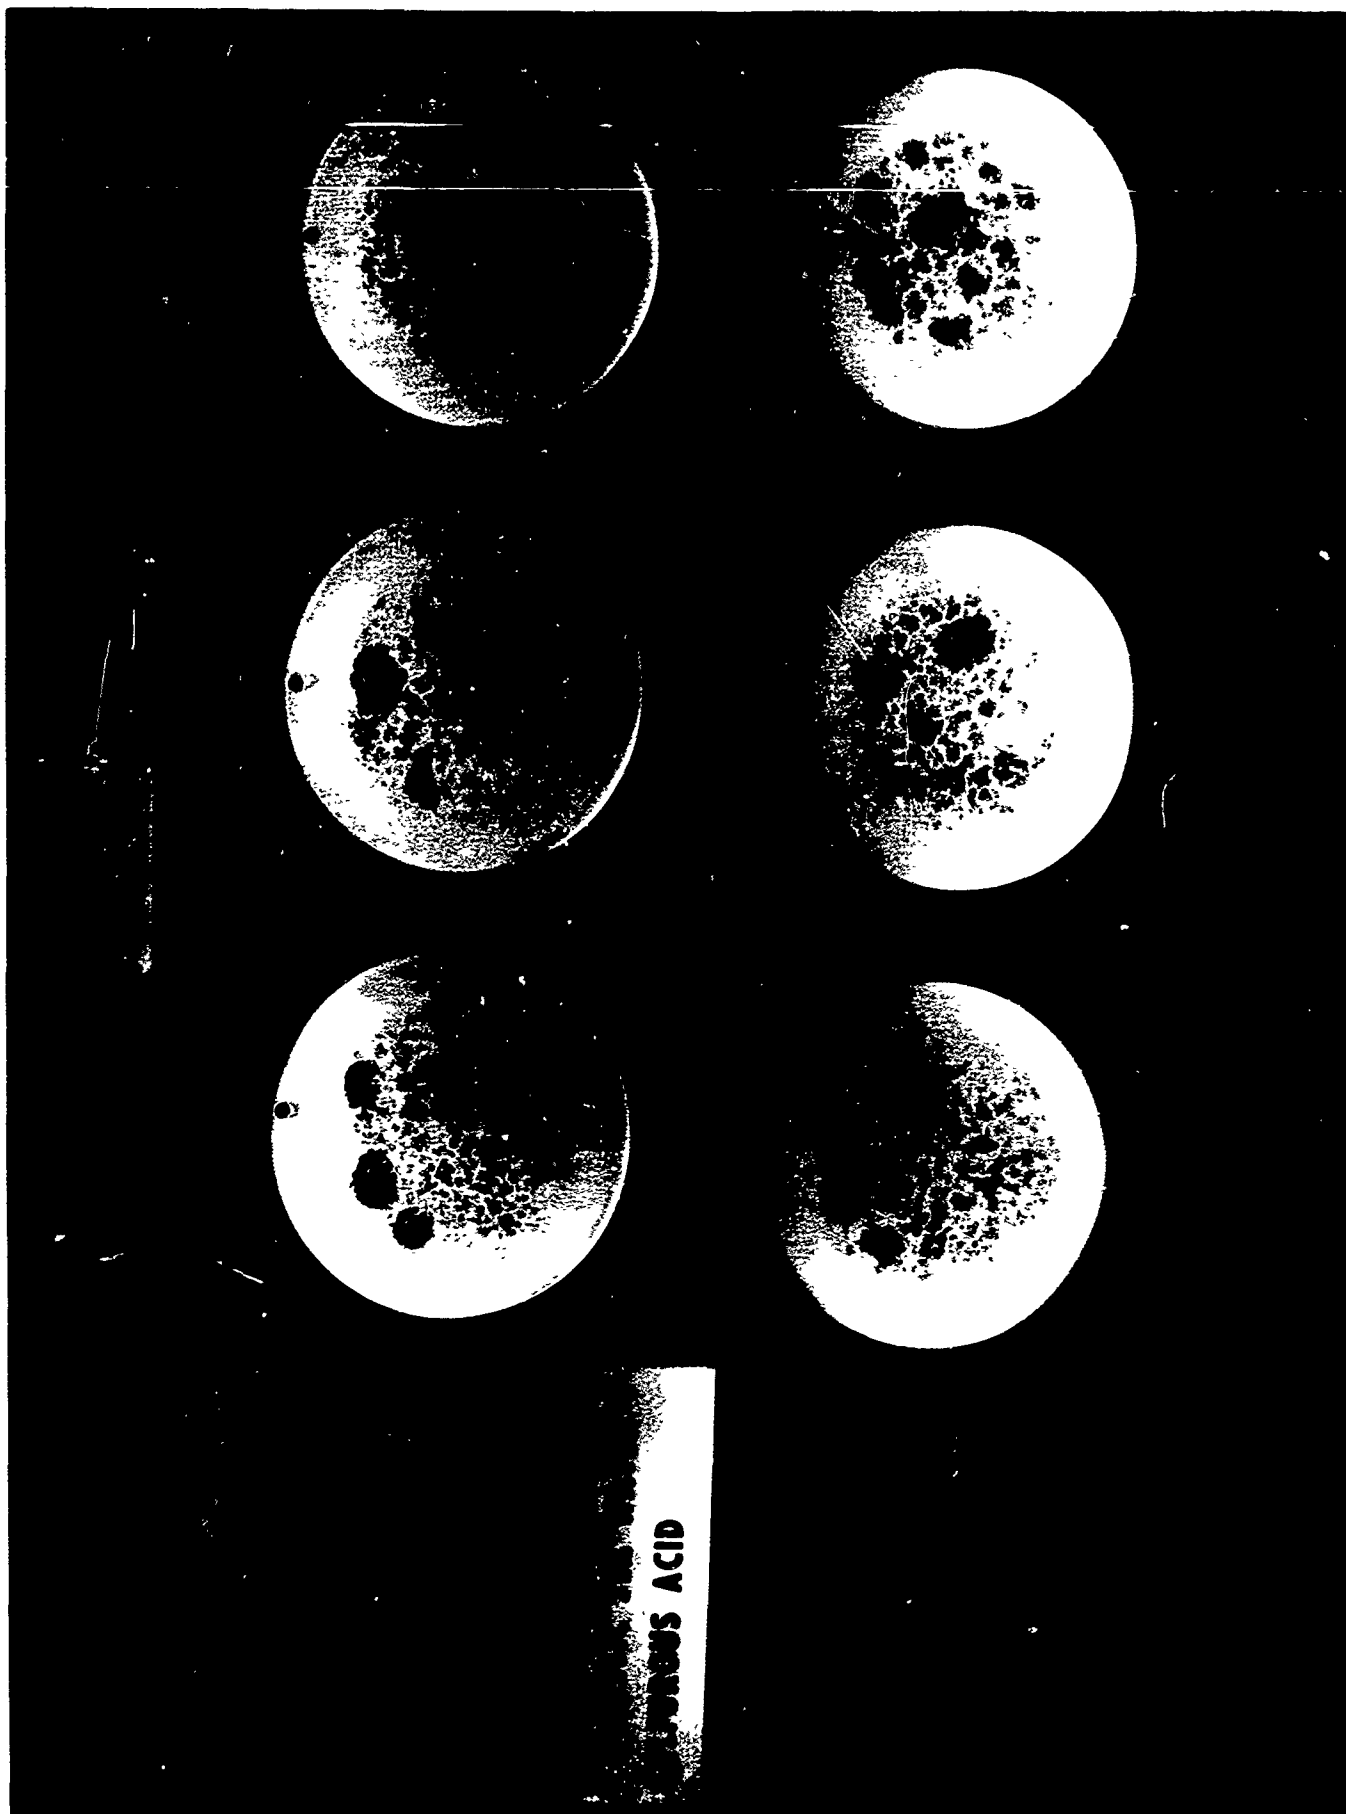
PLATE 18

RESULTS OF EXPOSURE OF STEEL SPECIMENS (COATED WITH A LIGHT OIL CONTAINING 50% INHIBITOR) TO A SYNTHETIC SEA WATER/ACID ENVIRONMENT

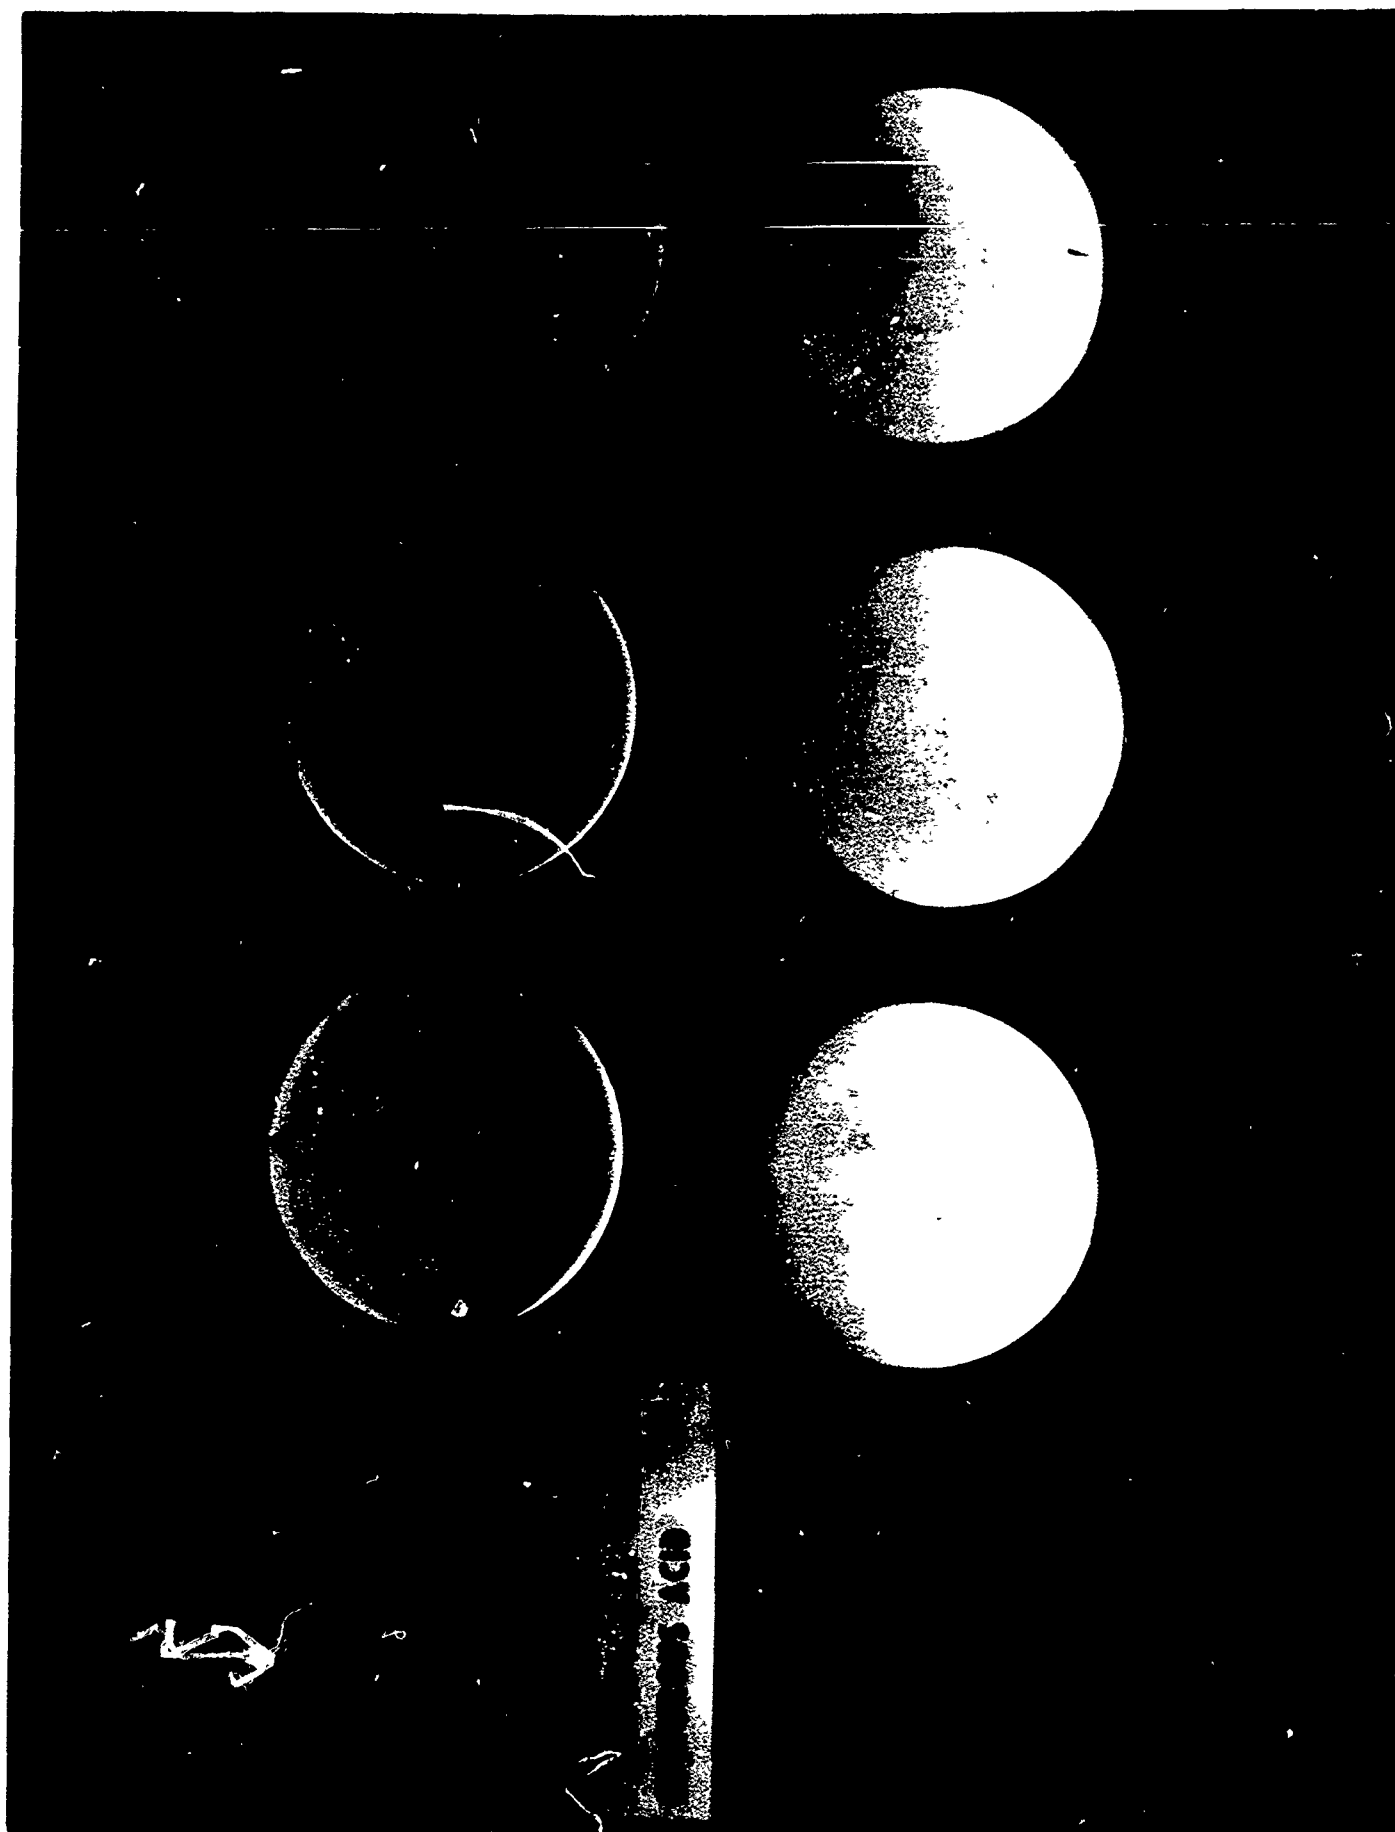
PLATE 19

RESULTS OF EXPOSURE OF STEEL SPECIMENS (COATED WITH A LIGHT OIL CONTAINING 60% INHIBITOR) TO A SYNTHETIC SEA WATER/ACID ENVIRONMENT

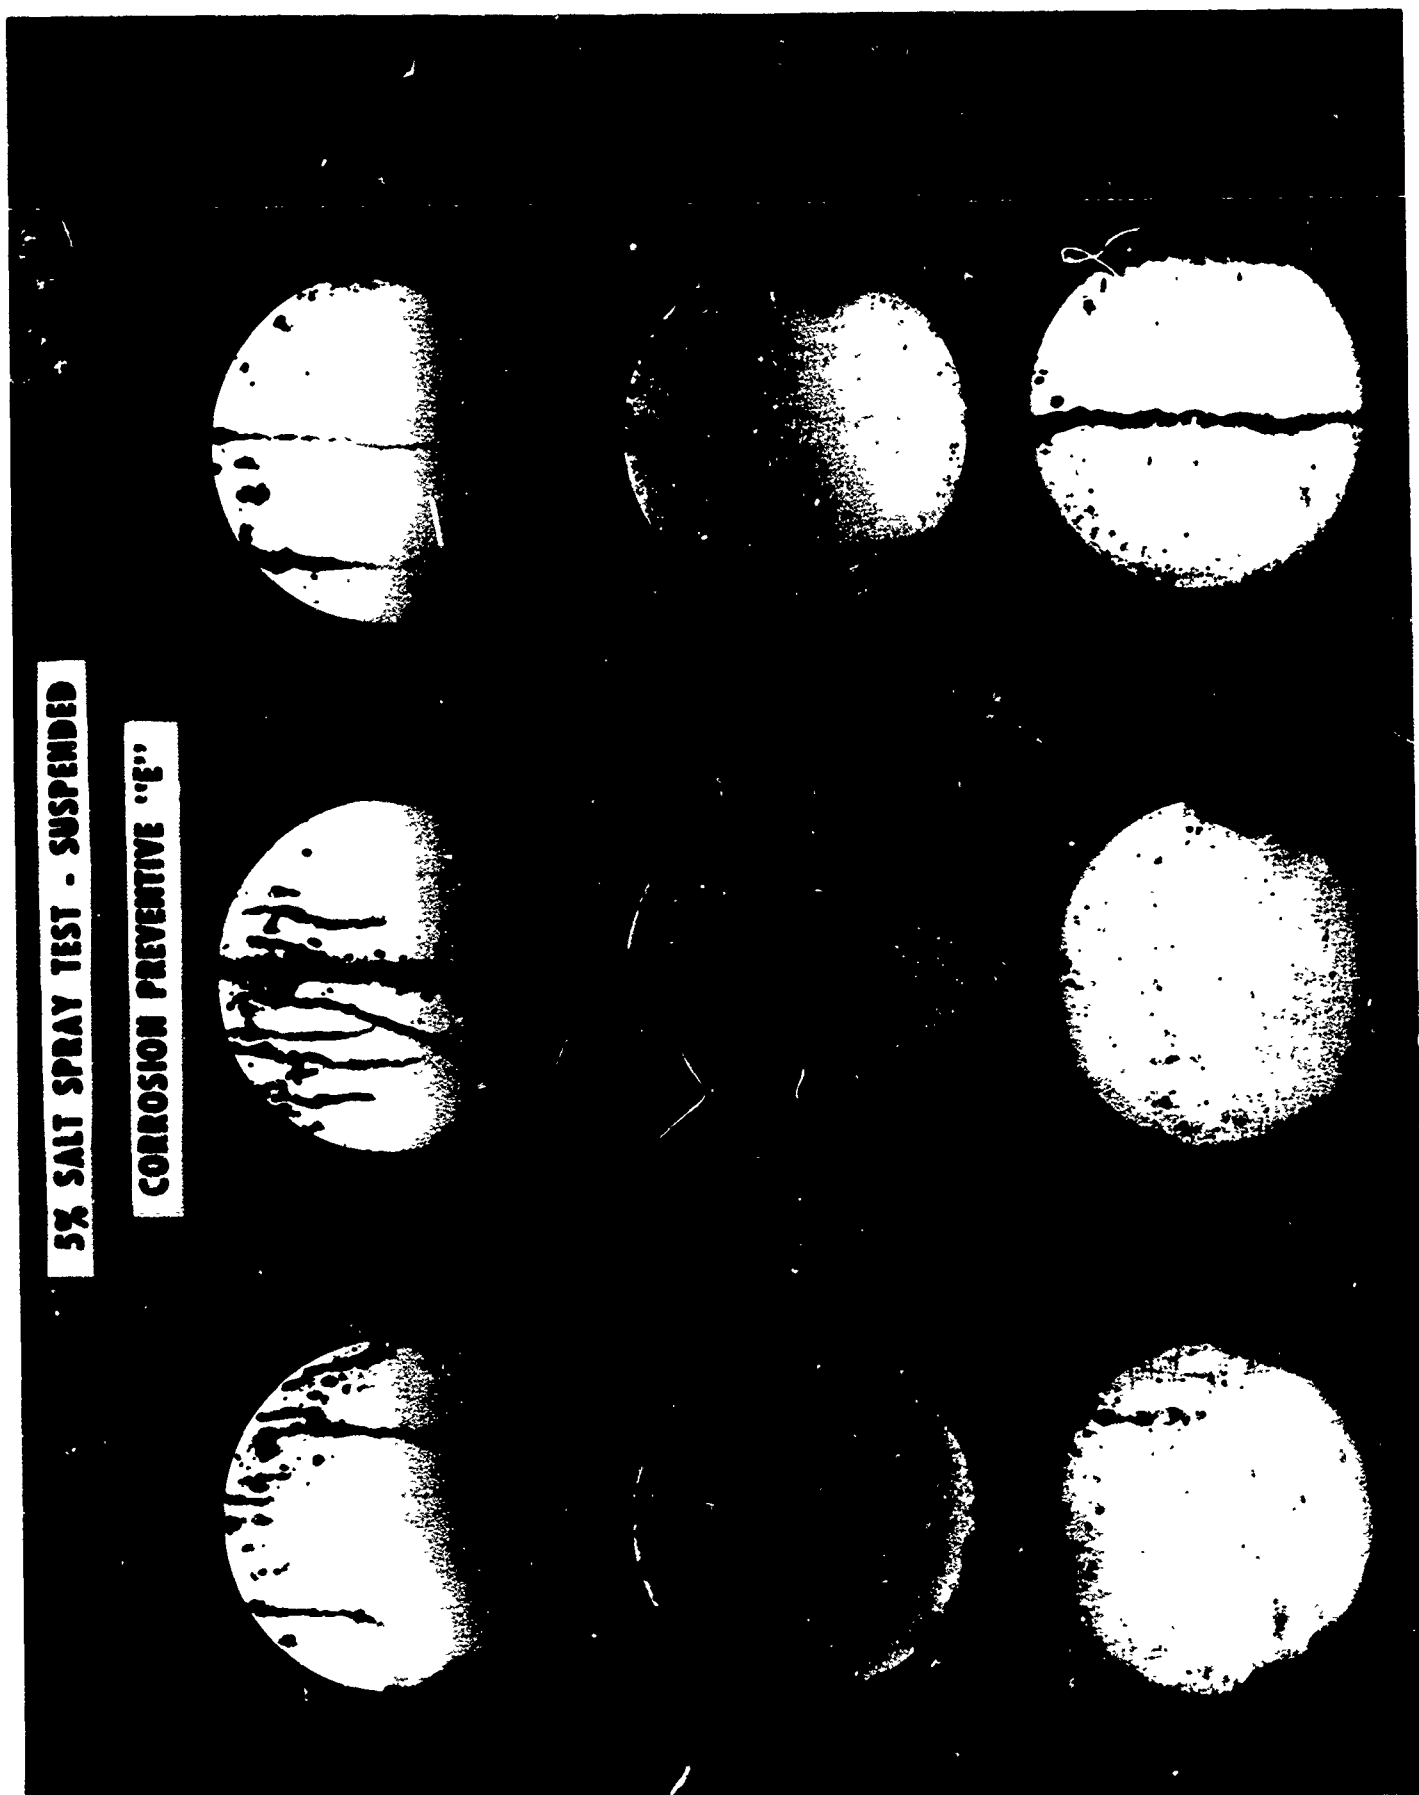
PLATE 20

5% SALT SPRAY TEST - SUSPENDED

RESULTS OF EXPOSURE OF STEEL SPECIMENS (COATED WITH A LIGHT OIL CONTAINING 60% INHIBITOR) IN THE 5% SALT SPRAY CABINET

In still another test, steel discs as used in the wet test chamber tests, were coated with a light oil containing 60% inhibitor (identified as sample E) and suspended in the 5% NaCl solution salt spray cabinet until failure occurred. The results of this test too showed the specimens failed at different times, and as shown in Plate 20, the specimens were rust streaked and spotted and the patterns were not uniform.
